Flight Motor Set 360L006 (STS-34) Final Report

Volume I - System Overview

February 1990

Thiokol CORPORATION
SPACE OPERATIONS

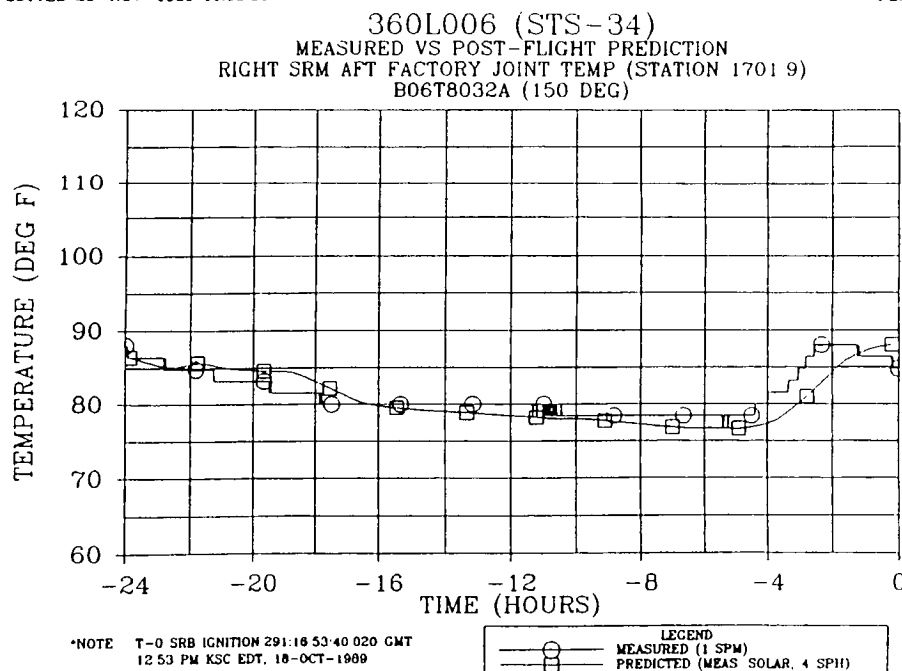
Figure 4-120. RH SRM Aft Factory Joint Temperature at Station 1701.9, B06T8032A (150-Deg) — Measured Versus Postflight Prediction

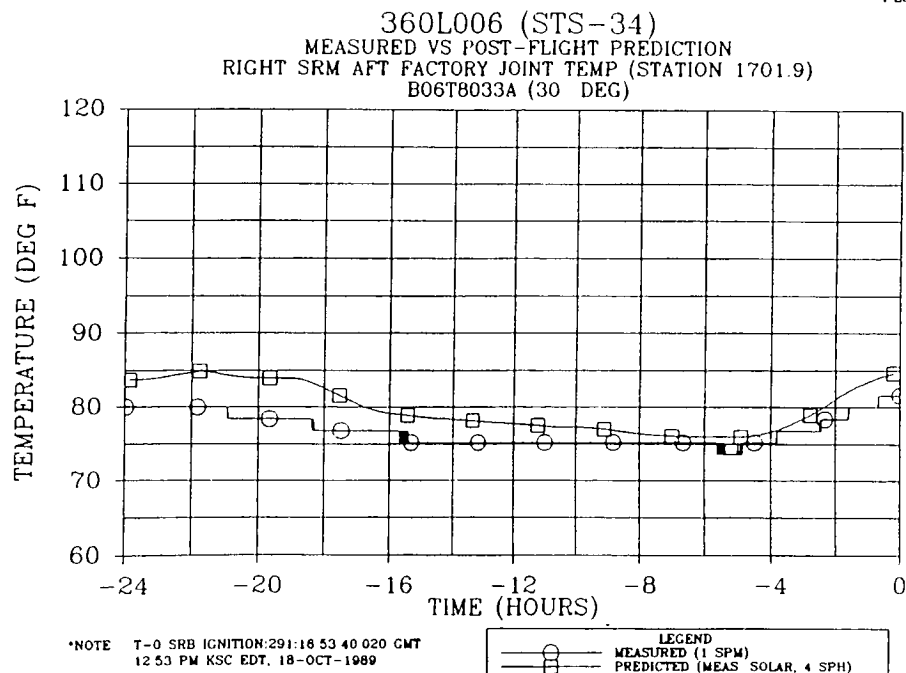
Figure 4-121. RH SRM Aft Factory Joint Temperature at Station 1701.9, B06T8033A (30-Deg) — Measured Versus Postflight Prediction

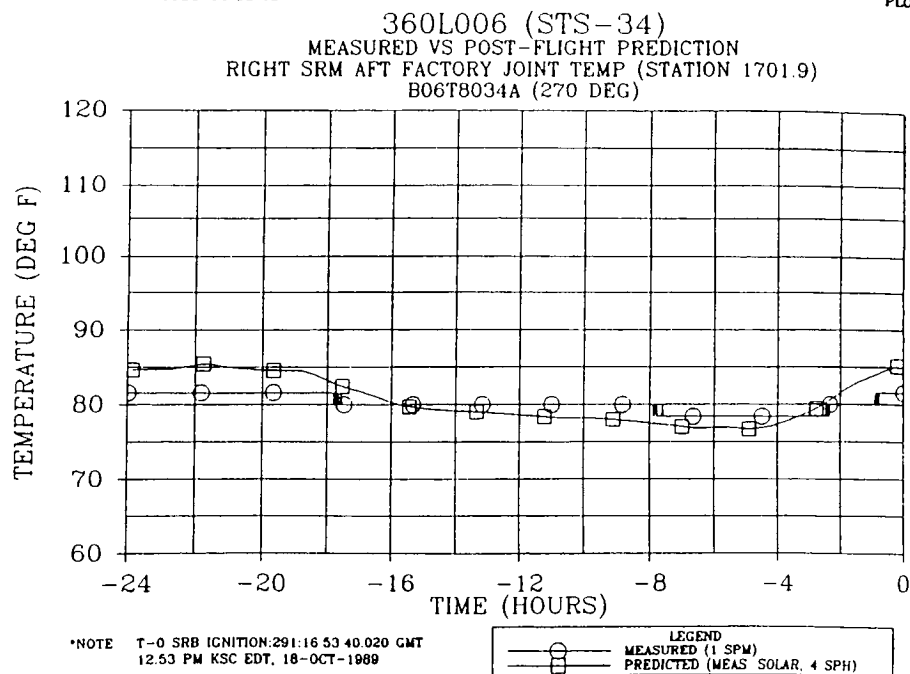
Figure 4-122. RH SRM Aft Factory Joint Temperature at Station 1701.9, B06T8034A (270-Deg) — Measured Versus Postflight Prediction
